# The Three Most Common Electrical Safety Issues in Deployed Environments

The U.S. standard voltage of 120 creates problems for Soldiers deployed to countries where the standard voltage is 220. Ignorance and carelessness when working with these voltages can have disastrous results.

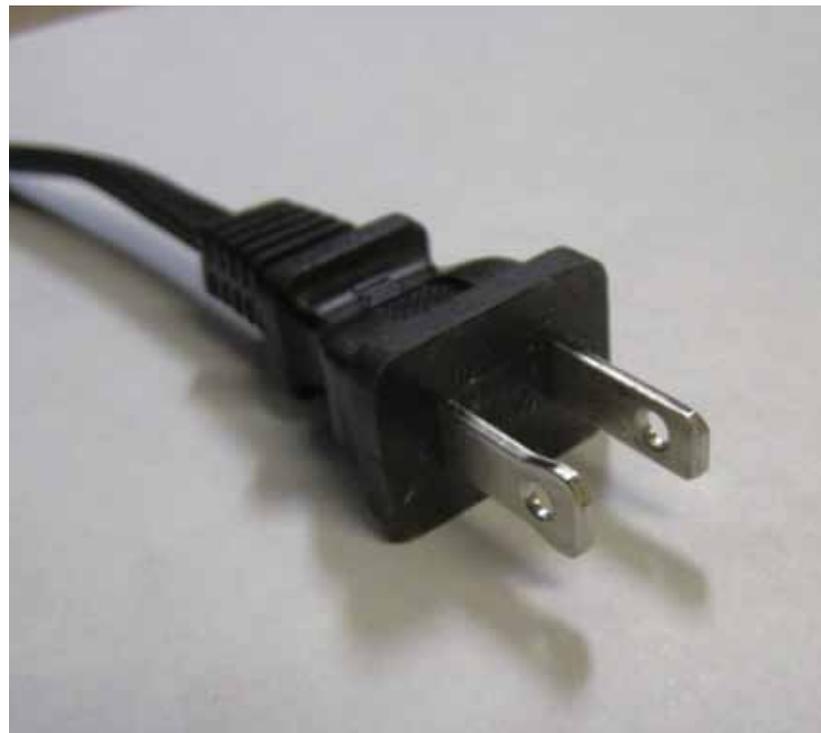
*Unlike devices in most other countries, most U.S. electronic devices use 120 volts. Their plugs have two blades (type A) or two blades and a grounding prong (type B).*

The primary reason U.S. military personnel purchase and use Chinese power strips is their multiple-use outlets. Soldiers are familiar with the National Electrical Manufacturers Association type A and type B plugs, the standard American two-blade plug. (Type A has no grounding prong; type B has one.) Those who are serving or have served in Europe are familiar with the type C, E, and F prong-style plugs. (For an excellent summary of plug configurations, see [http://en.wikipedia.org/wiki/Electrical\\_plug](http://en.wikipedia.org/wiki/Electrical_plug).) However, the type G, or British Standard 1363 plug, is widely used in Southwest Asia. Soldiers are often mystified by the various plugs and outlets.

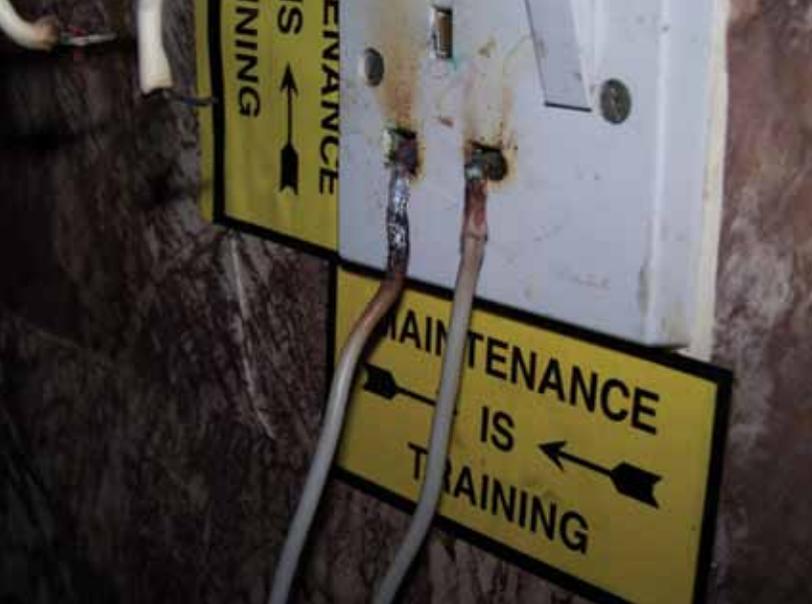
*Stripping wires and putting them into outlets is a common method of bypassing adapters. It is illegal and extremely dangerous.*

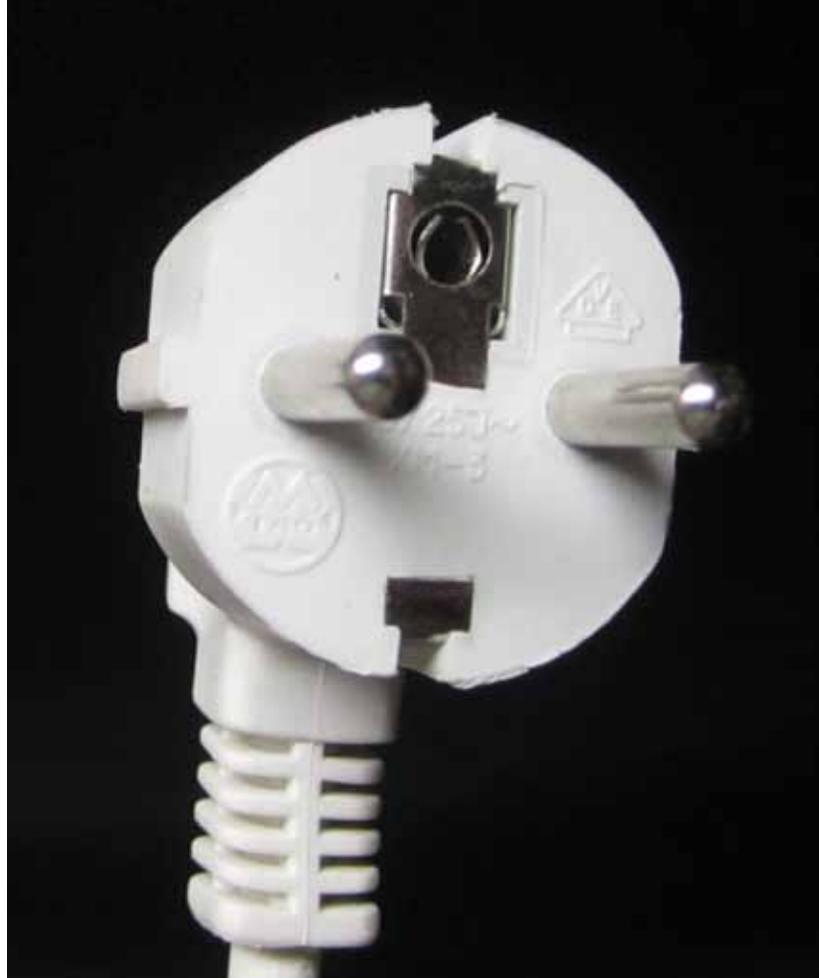
*Above, this photo shows type E or F Europlug with ground. Types D, E, and F are very similar. Below, type G British Standard 1363 plugs are often found in Southwest Asia. A fuse below the red cover will blow and protect the circuit.*

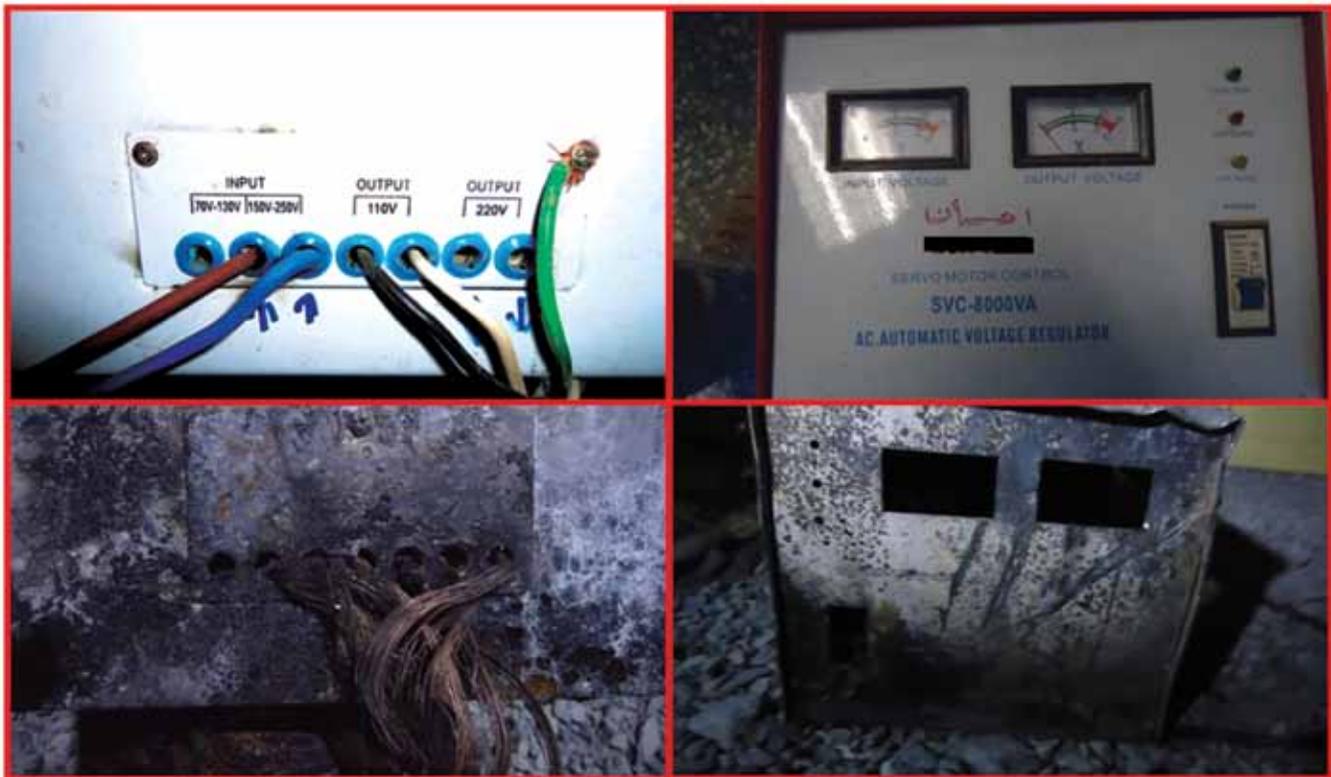
*This non-CE certified step-up/down voltage transformer and regulator was the cause of a fire at an operating base in Afghanistan. Procuring safe transformers is difficult since most are not CE approved and many have counterfeit CE logos applied by Chinese manufacturers.*

Step-up/down voltage transformers provide a solution, but the primary source for these appliances is—you guessed it—China. After electricians employed by a U.S. contractor in Afghanistan inspected new locally-purchased step-up/down transformers, they were determined to be unsafe. Manufactured in China, they

included a counterfeit CE logo carefully stenciled on the side. A visit to the company website revealed a link to the CE certificate—a handsome piece of paper with fancy script suitable for framing. It was counterfeit; there was no CE approval.

When an electrician checked the transformer schematic posted on the website, he determined that the ground was insufficient and the product presented a serious fire and shock hazard. A Google search for “unsafe Chinese transformers” reveals a wide variety of perspectives, with most experts advising caution when purchasing Chinese electrical products and many highlighting the widespread counterfeit certification problem.

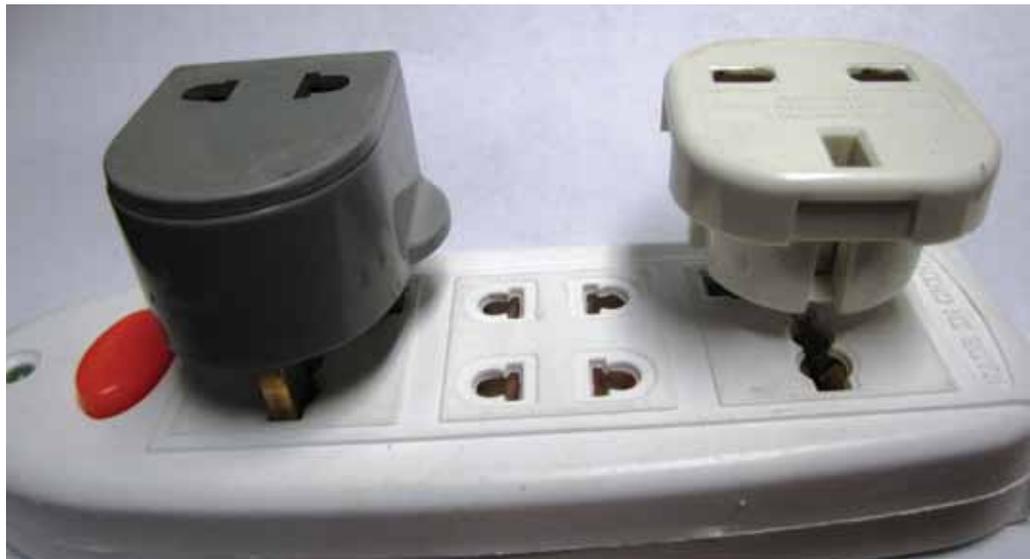
*Chinese power strips are often poorly constructed and easily catch on fire. However, their multiuse outlet configurations make them very appealing. They are not UL or CE approved and are not allowed on U.S. military facilities in Southwest Asia.*
